The effect of zirconia surface architecturing technique on the zirconia/veneer interfacial bond strength

KEYWORDS: Zirconia; Zirconia surface architecturing technique (ZSAT); Scratch test; Tensile strength test

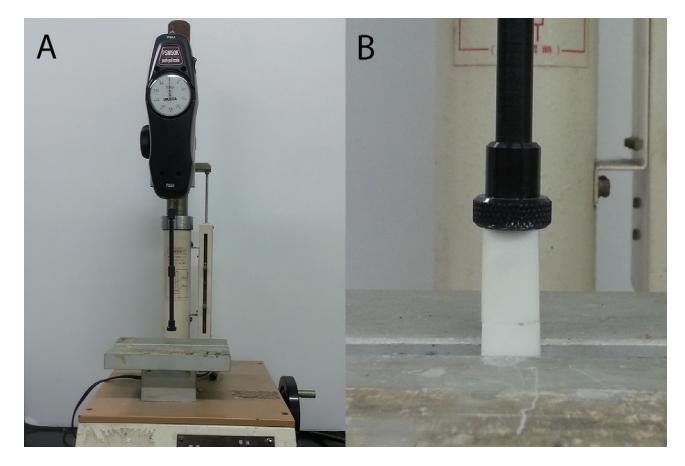
Fig. 1. (A) Push-pull tension gauge 5005, (B) Specimen loaded for tensile strength test (See the line of bonded interface between two zirconia blocks).

Another 60 rectangular column blocks ($5 \times 5 \times 10$ mm) were made with 3Y-TZP blocks (Acucera Inc., Pocheon, Korea) after sintering for 2 hours at 1550°C for tensile strength test. Mirror surface finishing was performed, and then 30 blocks were treated with ZSAT for 2 hours at room temperature. A control group of another 30 specimens did not receive the surface treatment. Then, porcelain powders were applied, and these were fired for 30 seconds at 920°C. Tensile strength testing of the zirconia-porcelain binding area was performed using a push-pull tension gauge 5005 (Imada Co., Ltd., Toyohashi, Japan) (Fig. 1).

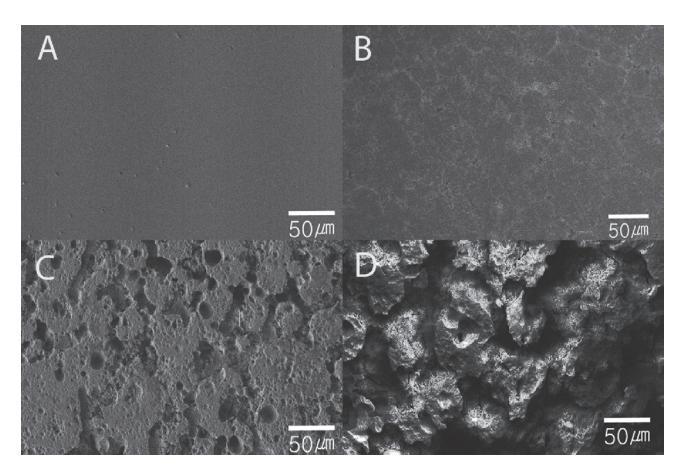
Fig. 2. (A) Zirconia surface before surface treatment, (B) Zirconia surface after surface treatment for 1 hour, (C) Zirconia surface after surface treatment for 2 hours, (D) Zirconia surface after surface treatment for 3 hours.

After the surface treatment was done, an even thickness of porcelain powder was applied, and the final porcelainfused zirconia specimen was finished with heat treatment. The final thickness of the porcelain was about 0.2 mm. The treated surface of the zirconia ceramic was observed under SEM (FESEM, JEOL JSM-6700F, Tokyo, Japan) with a magnification of $250\times$, and the bond strength between the zirconia ceramic and porcelain was measured using the scratch test method.

Changes in the surface of the zirconia ceramics were observed over time, especially where the zirconia surface was etched by acid. Etching formed indentations on the surface, which were intensified as treatment time increased (Fig. 2).
